**ROMOBE LAKE DAM**

**NDI No. PA 00051**

**PHASE I INSPECTION REPORT  
NATIONAL DAM INSPECTION PROGRAM**

**April 1981**

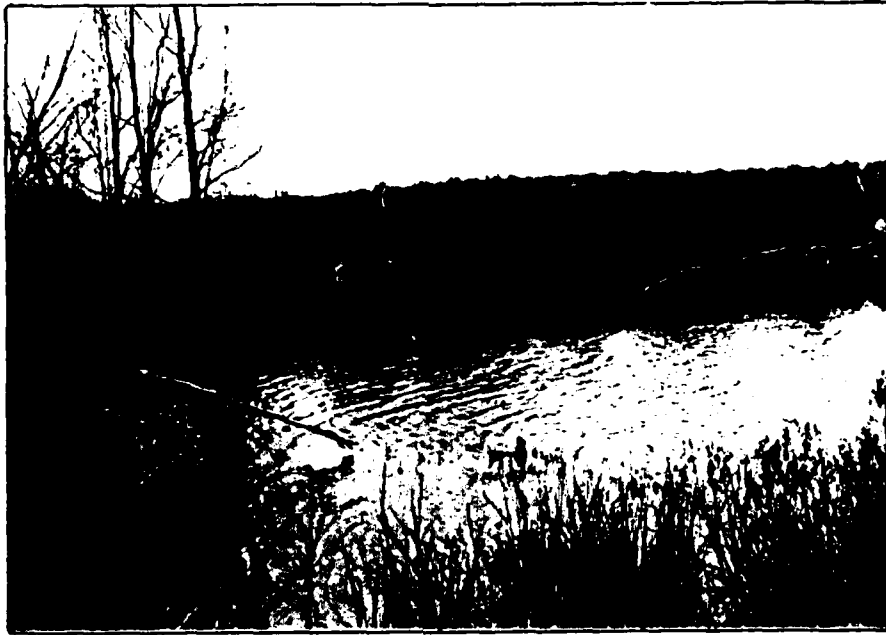
Overall View of Upstream Face of Dam (Looking Downstream)

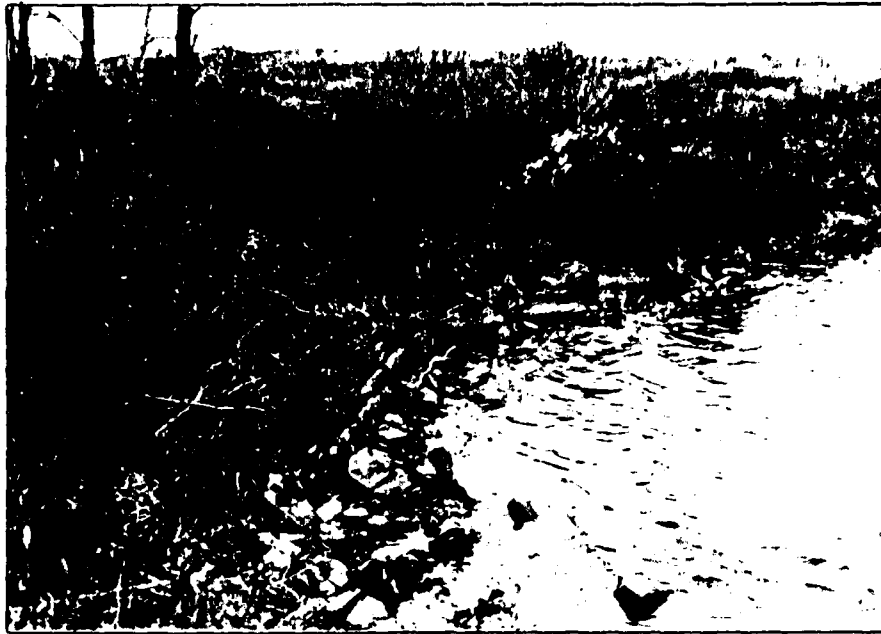
PHOTO 1. View of Upstream Face of Dam from Left Abutment

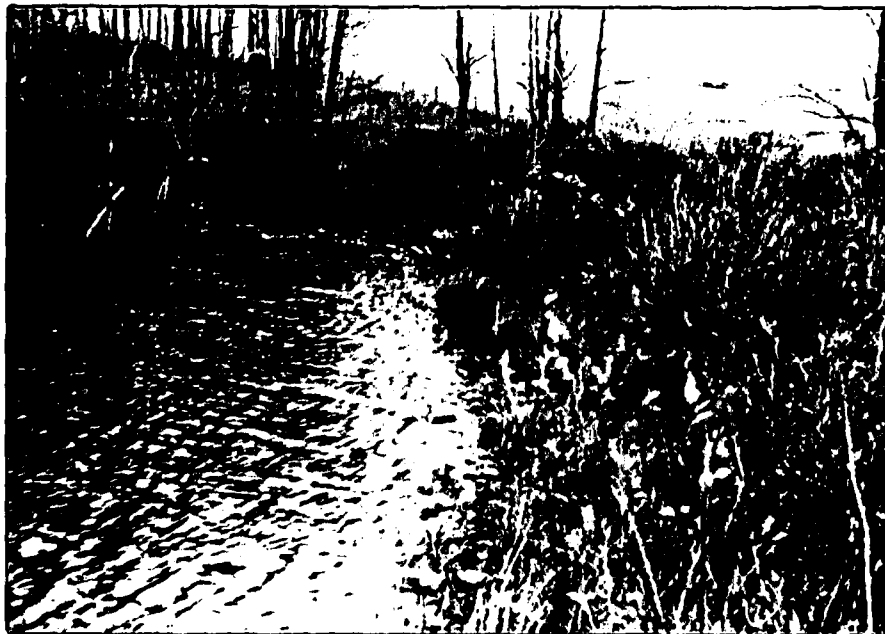
**PHOTO 4. View of Upstream Face of Dam from Right Abutment**  
(Note: Spillway Channel Located to Left of Fence in Upper Left Portion of Photograph)
